# **Navajo Abandoned Uranium Mine**

## **Site Screen Report**

### **NA-0924 AUM Site**

**August 2010**

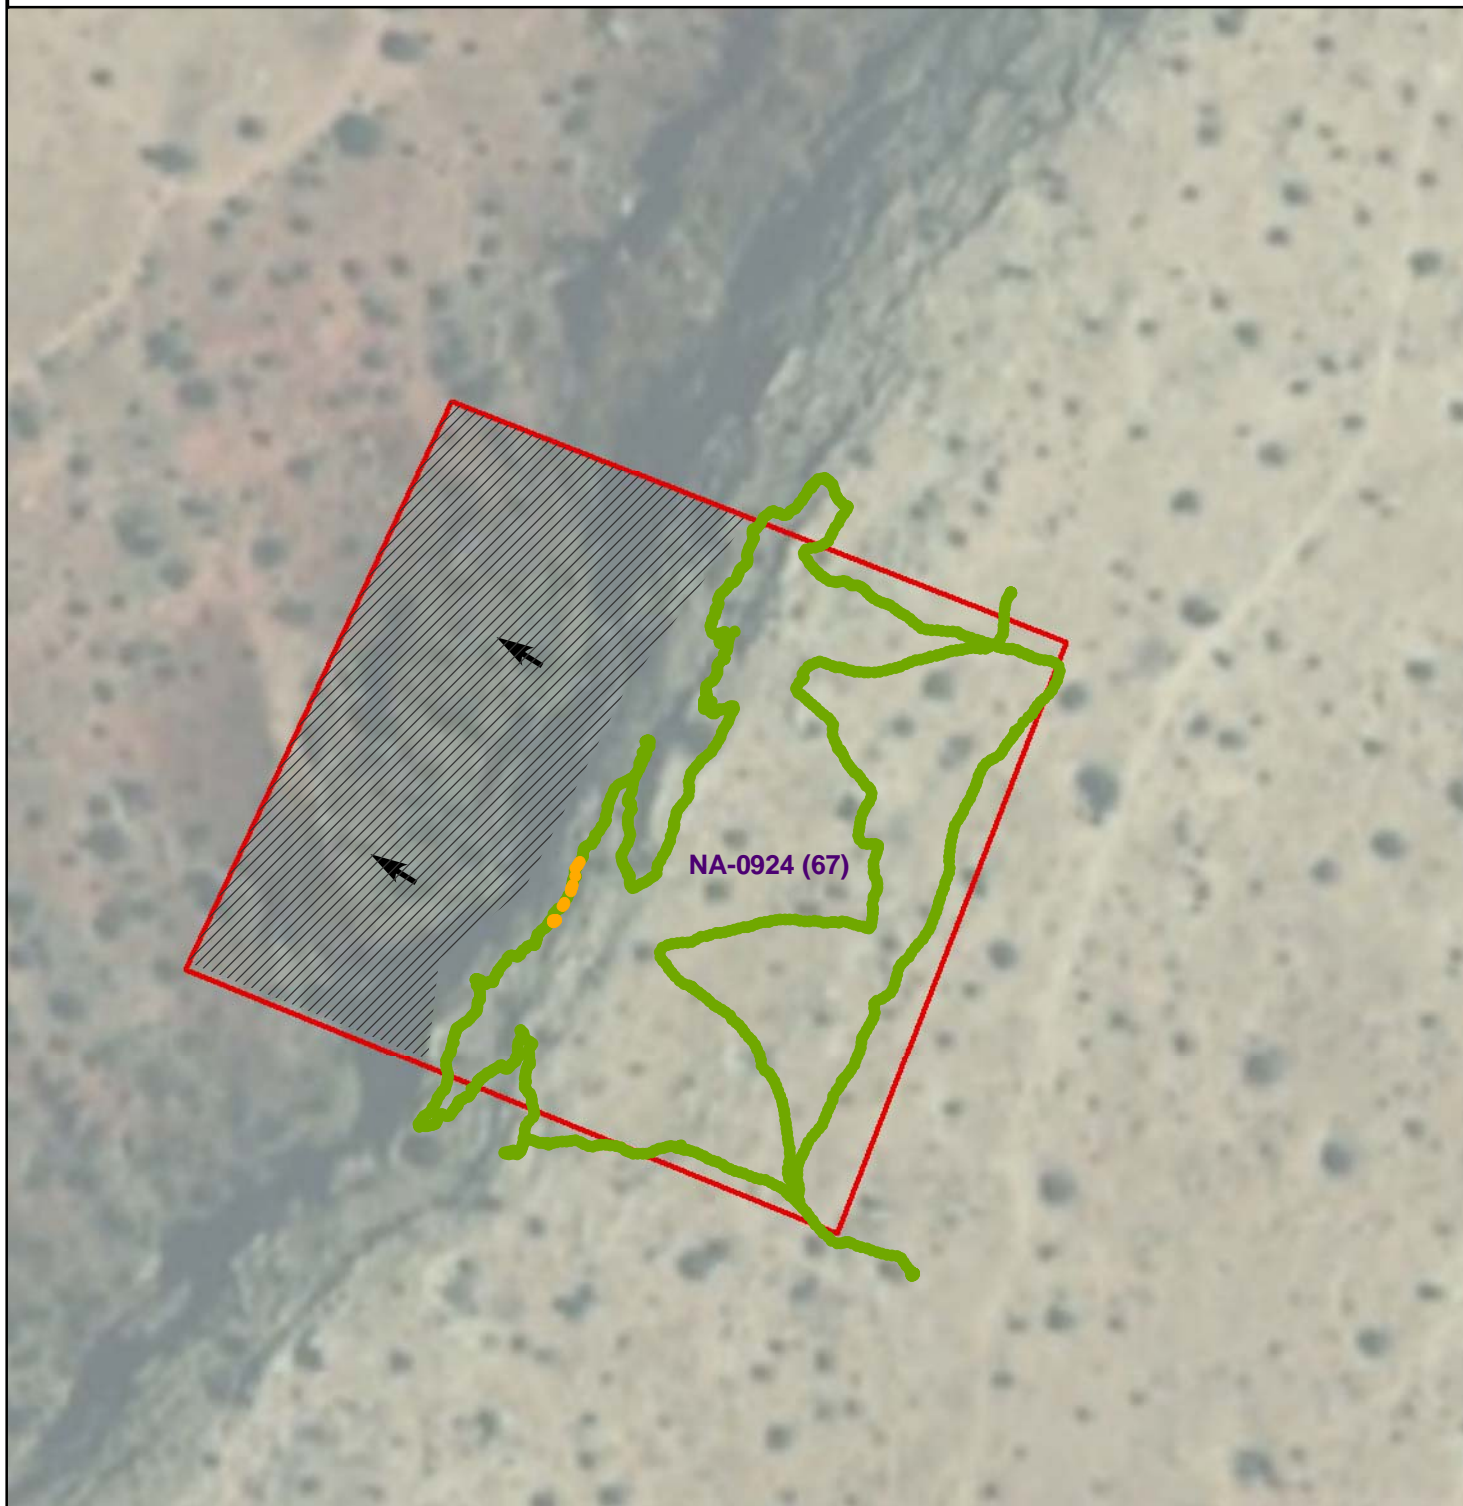
**Figure 1 - Gamma Radiation Measurements, Above Two Times Background  
NA-0924 (67)  
Sweetwater / Teec Nos Pos Chapter, Navajo Nation**

A total of 1,405 gamma radiation measurements were collected from the mine site, ranging from 7,353 cpm to 58,286 cpm. The measurements are represented in Figures 1 and 2.

Gamma survey conducted 06/2010  
Measured as counts per minute (cpm)

Average background = 10,130 cpm

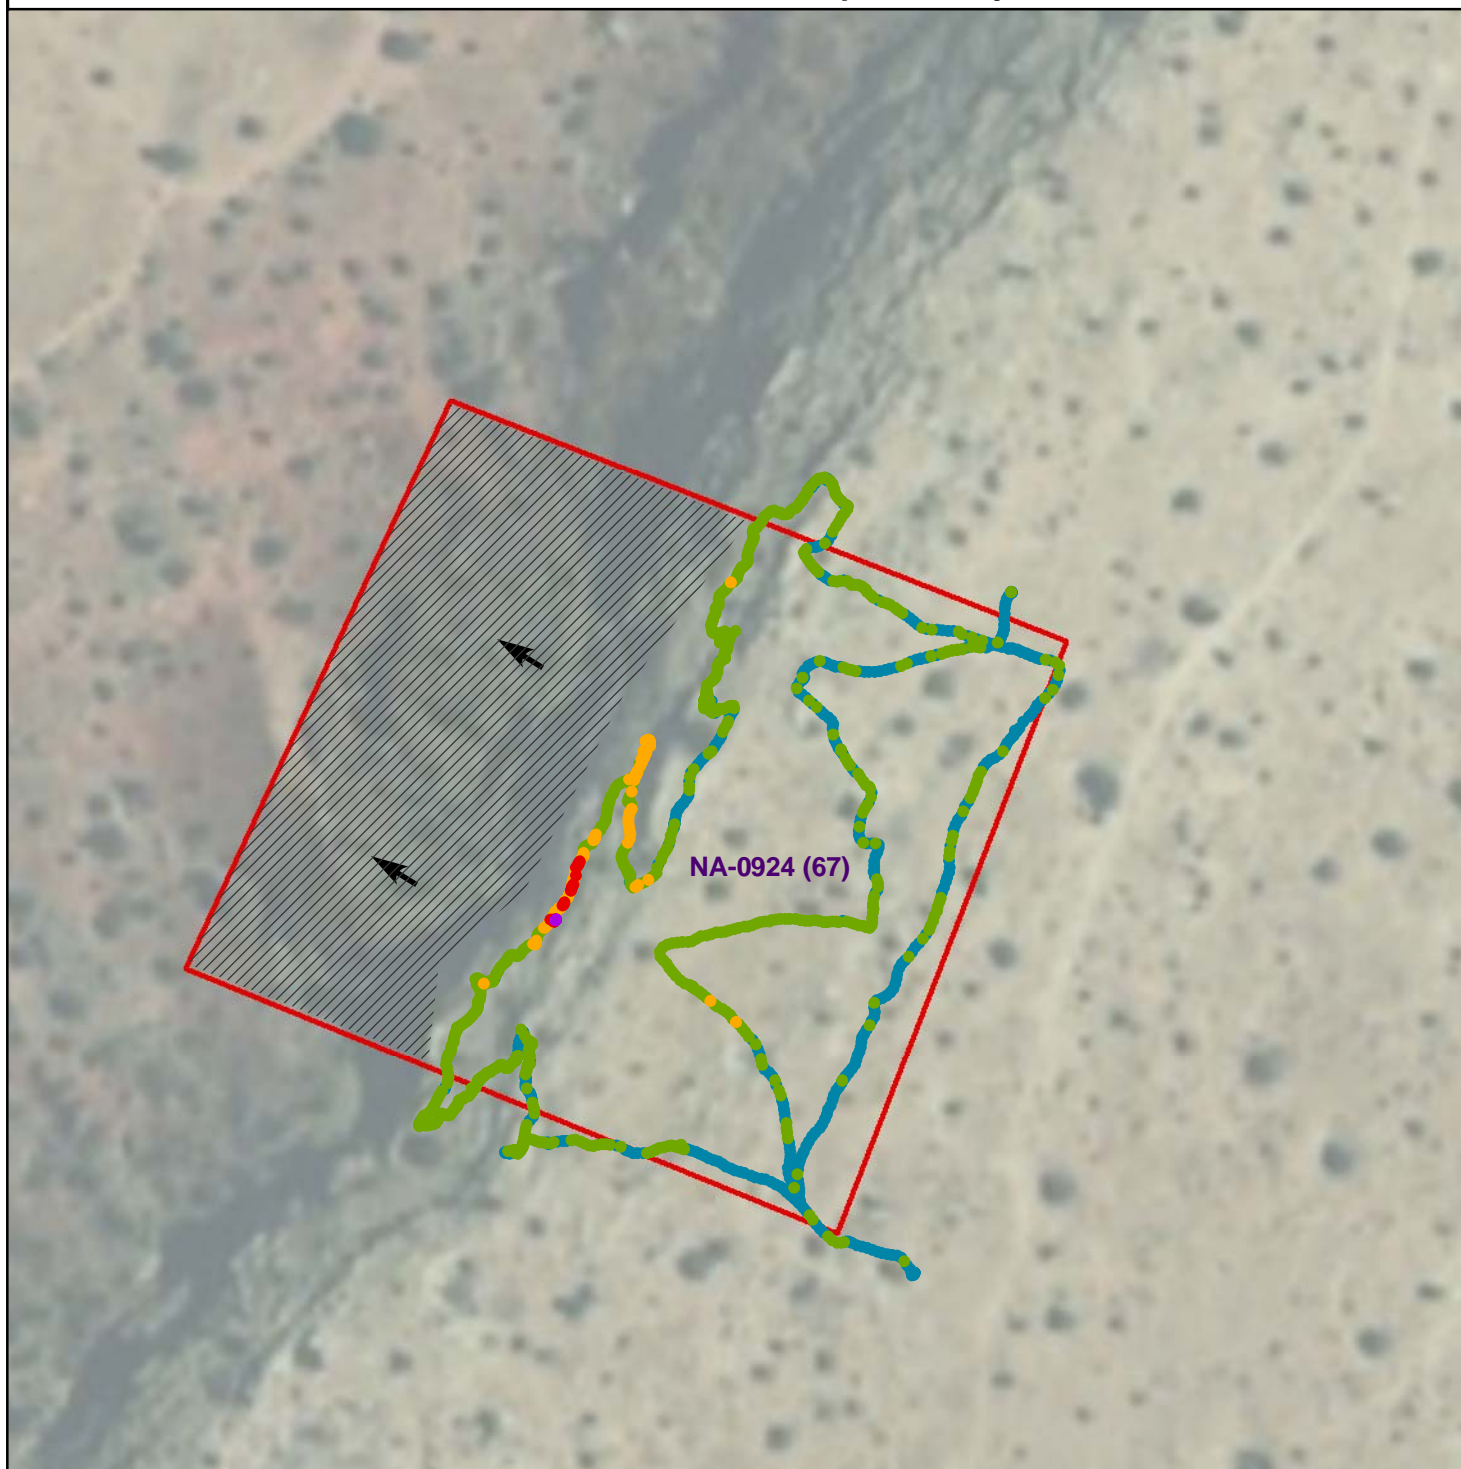
**Figure 2 - Gamma Radiation Measurements**  
**NA-0924 (67)**  
**Sweetwater / Teec Nos Pos Chapter, Navajo Nation**

Gamma survey conducted 06/2010  
 Measured as counts per minute (cpm)  
 Average background 10,130 cpm
